MINE OPERATING PLAN

**APPLICATION 04-105774
MINERAL MATERIALS**

**SOUTHWEST ¼ OF SOUTHEAST ¼ OF
SECTION 13, T7N, R7W
MARICOPA COUNTY, ARIZONA**

Subject: Final Mine Operating Plan
Forepaugh Mineral Pit
Maricopa County, Arizona
Application No. 04-105774

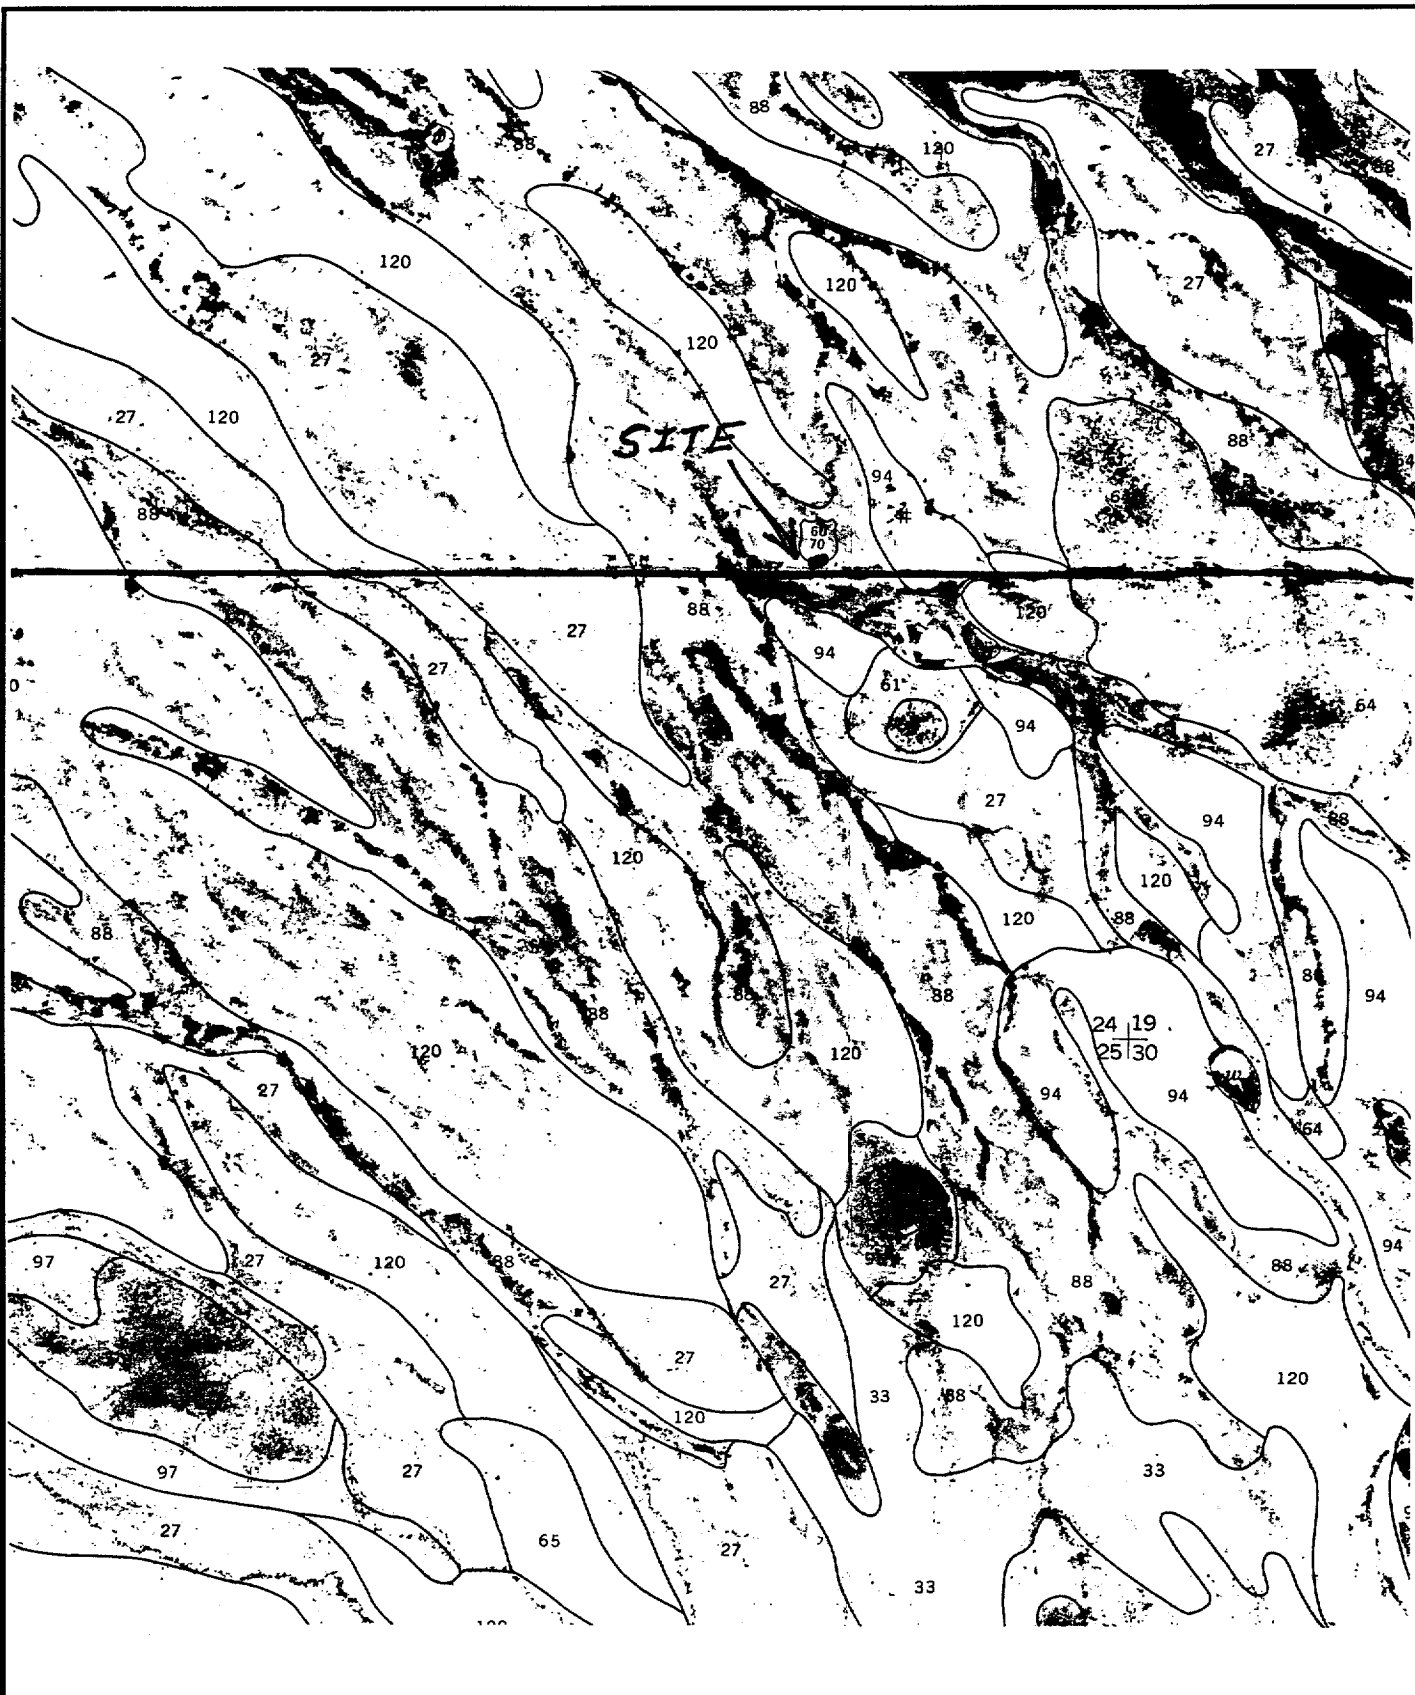
Figure 5
SOIL SURVEY MAP
FOREPAUGH MINERAL PIT
WEST OF WICKENBURG
MARICOPA COUNTY, ARIZONA

Soil Conditions – According to the United States Department of Agriculture (USDA), Soil Conservation Service, "Soil Survey of Aguila-Carefree Area, Parts of Maricopa and Pinal Counties, Arizona," the Site is located on the soils of the Mohave-Continental-Guest. These soils are generally nearly level and gently sloping, clayey and loamy soils located on fan terraces and flood plains. The soil complex listed for the area of the Site are Nickel-Cave, which are 50 percent gravelly sandy loam and 35 percent Cave gravelly loam. These soils have a moderate permeability, available water capacity is low, runoff is medium, and the hazard of water erosion is slight. These soils may have a high lime content.

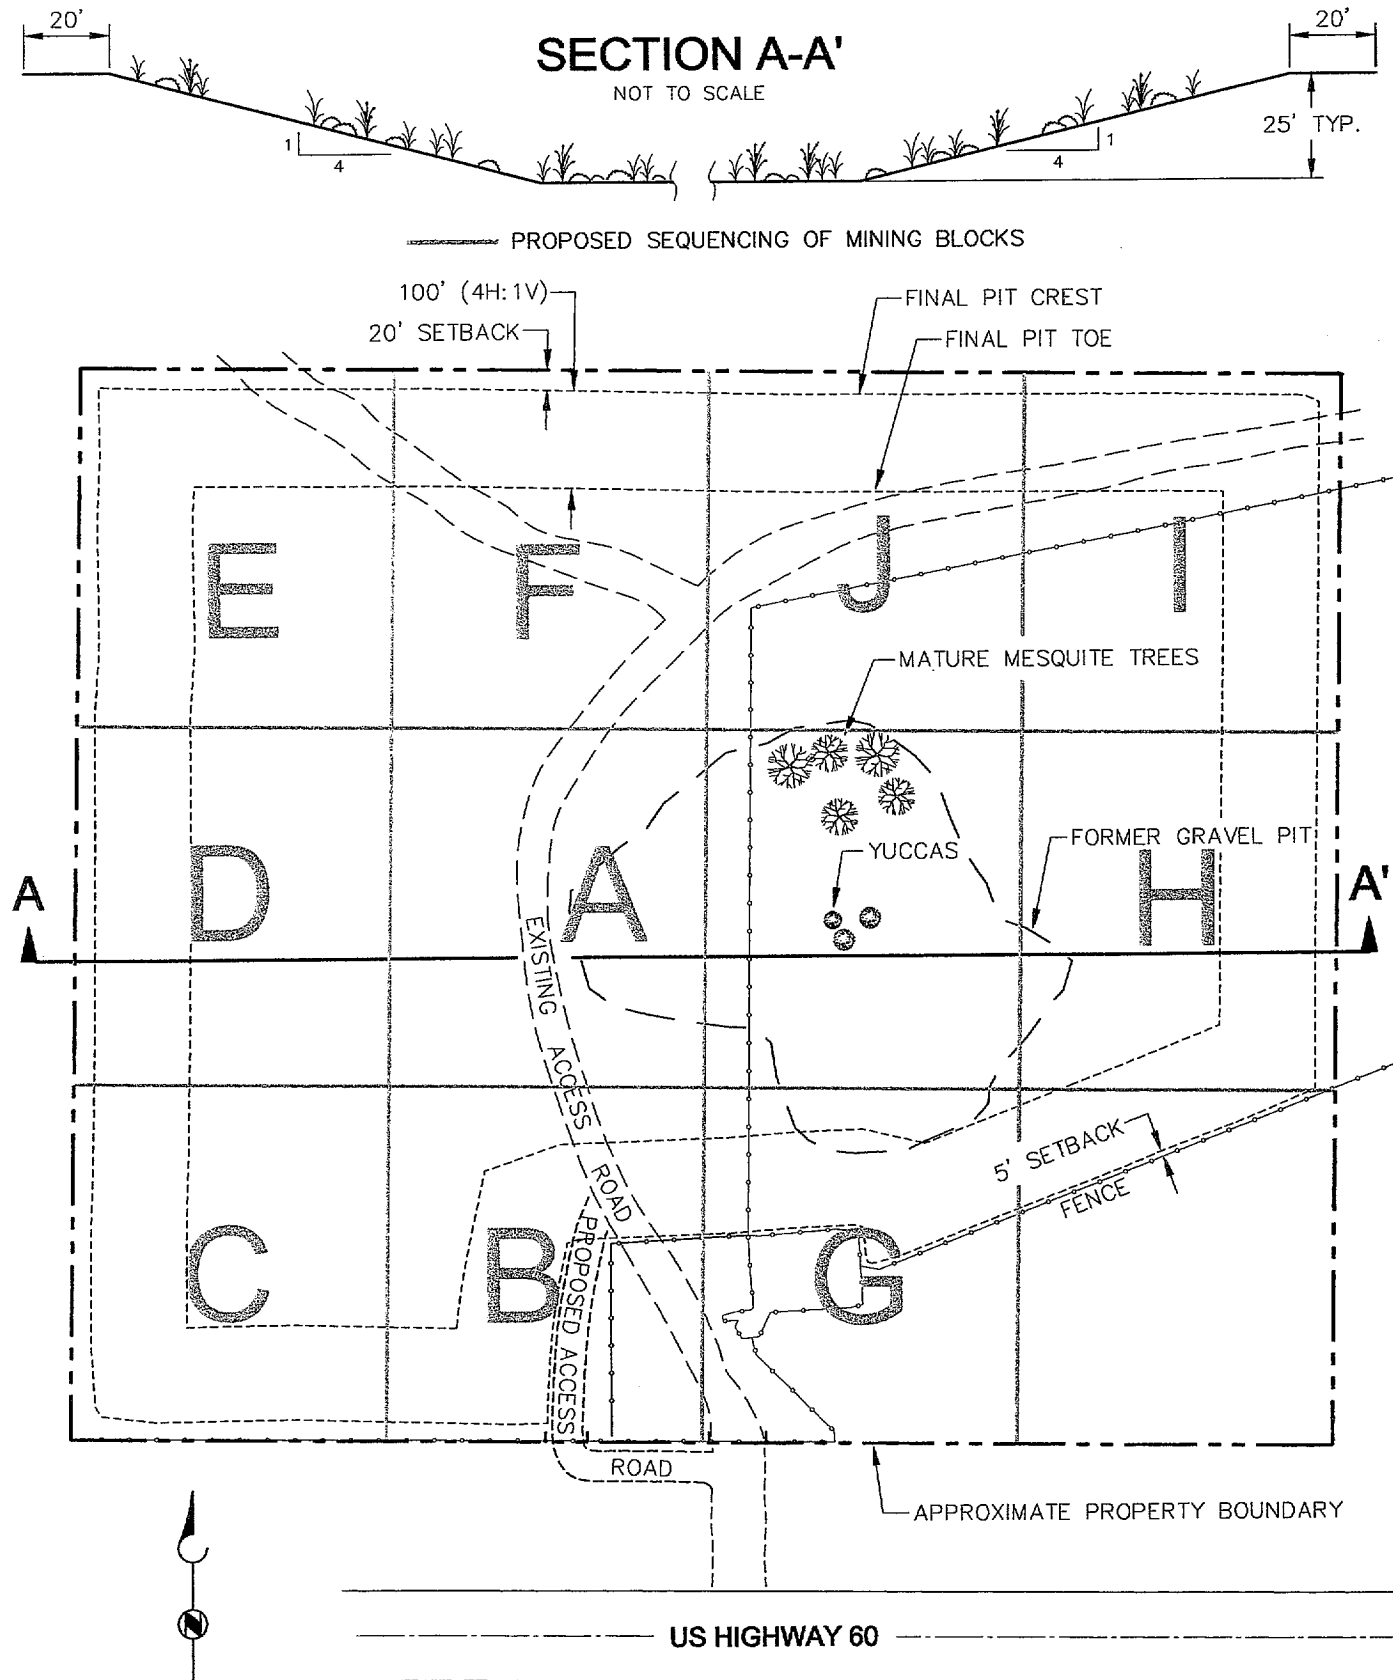
Figure 7

**EXCAVATION PLAN AND FINAL
PIT CROSS-SECTION A-A'**
U.S. HIGHWAY 60, WEST OF WICKENBURG
MARICOPA COUNTY, ARIZONA

Final slopes will be regraded to no steeper than 4H:1V and will be hydroseeded to promote rapid germination, which will aid in stabilizing the slope against soil erosion from runoff caused by precipitation.

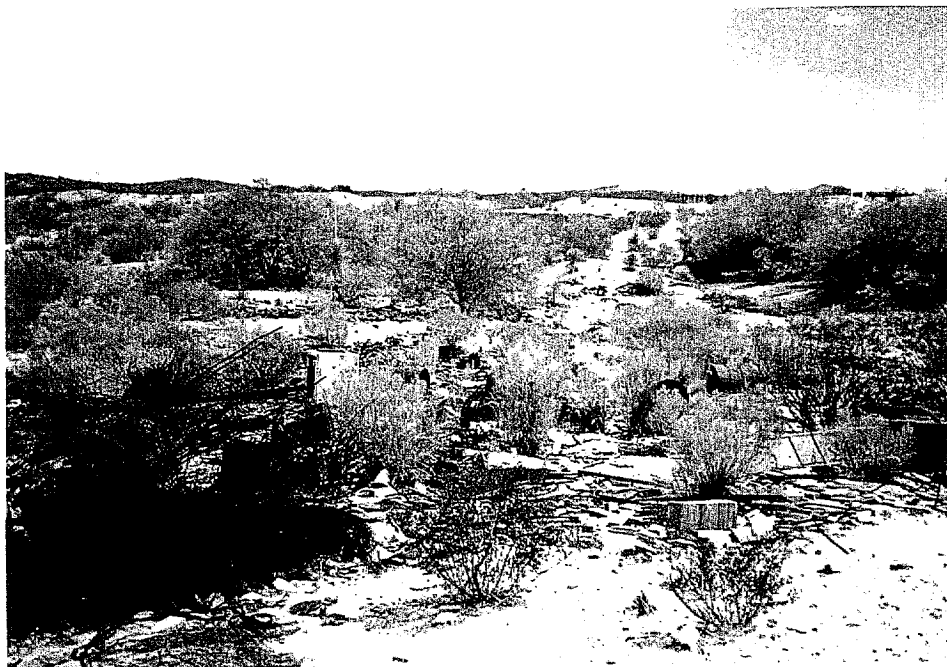
Photograph No. 1

View looking east at the dump area on the Site.

The Phase I ESA (Appendix A) identified previous unpermitted dumping of a large amount of trash and debris at the Site in the western portion of the former gravel pit. The debris was comprised of broken glass containers, household appliances, clothing, and other general domestic trash. Numerous empty bottles were also found that were labeled as some type of livestock antibiotic. Drums or potentially hazardous materials were not observed in the disposal area. Brown and Caldwell observed an empty compressed gas cylinder in the disposal area. A small refrigerator was noted in the disposal area that appeared to contain white insulation that is a suspect asbestos-containing material (ACM). A small abandoned travel trailer was observed at the Site located in the central portion of the south side of the former gravel pit. The small travel trailer may also contain ACM although access was not possible due to the presence of a beehive in the trailer. No other areas of dumping were observed at the Site.

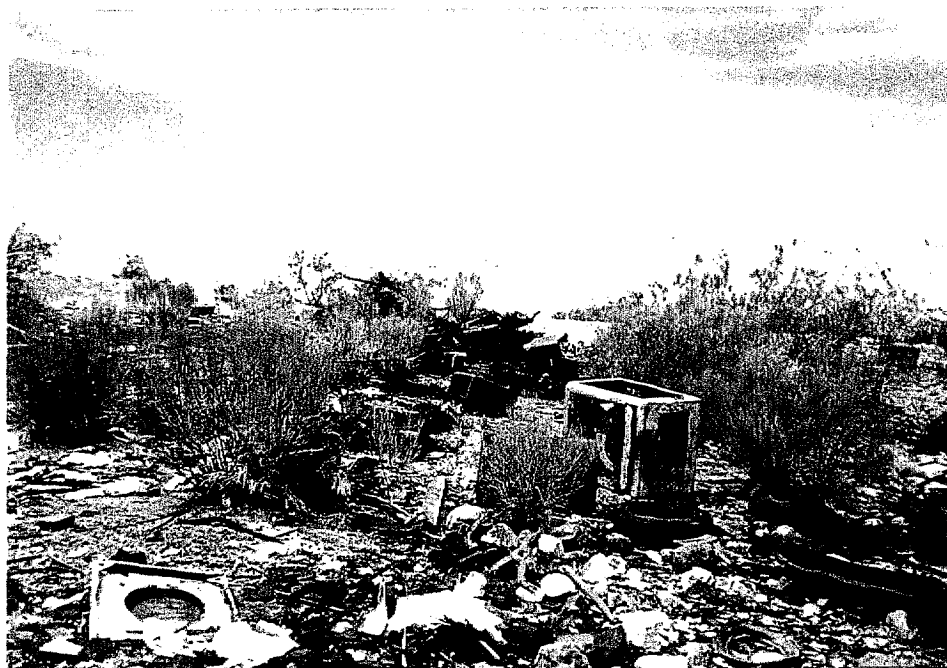
Photograph No. 2

View of the debris and trash in the dump area on the Site.

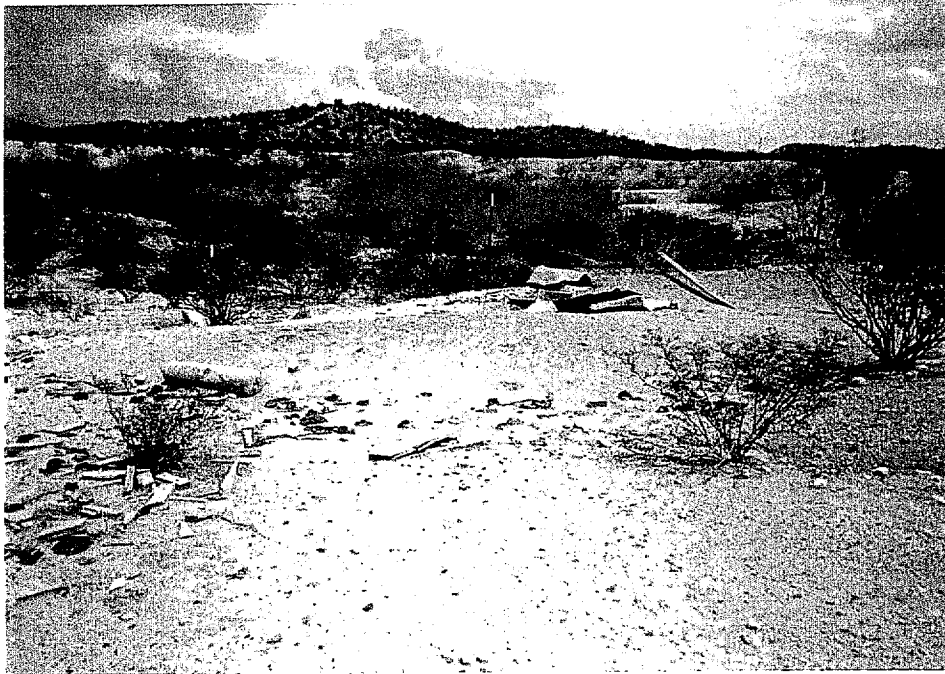
Photograph No. 3

View of the former compressed gas cylinder located near the south-central portion of the Site. Note the abandoned trailer in the upper right corner background of the photograph.

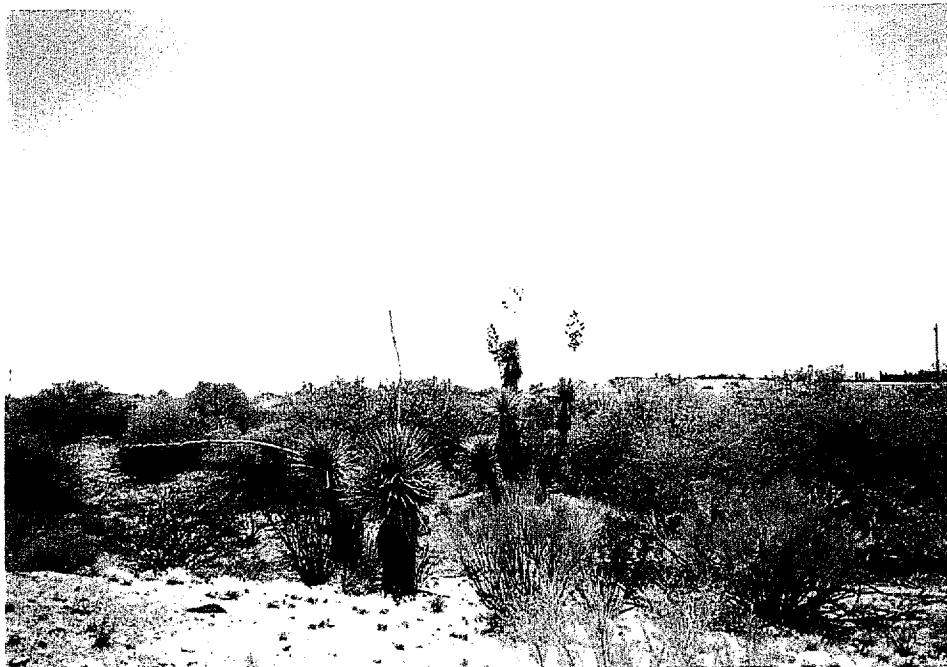
Photograph No. 5

View looking toward the east from the west side of the pit. Note the abandoned trailer in the center background of the photograph.

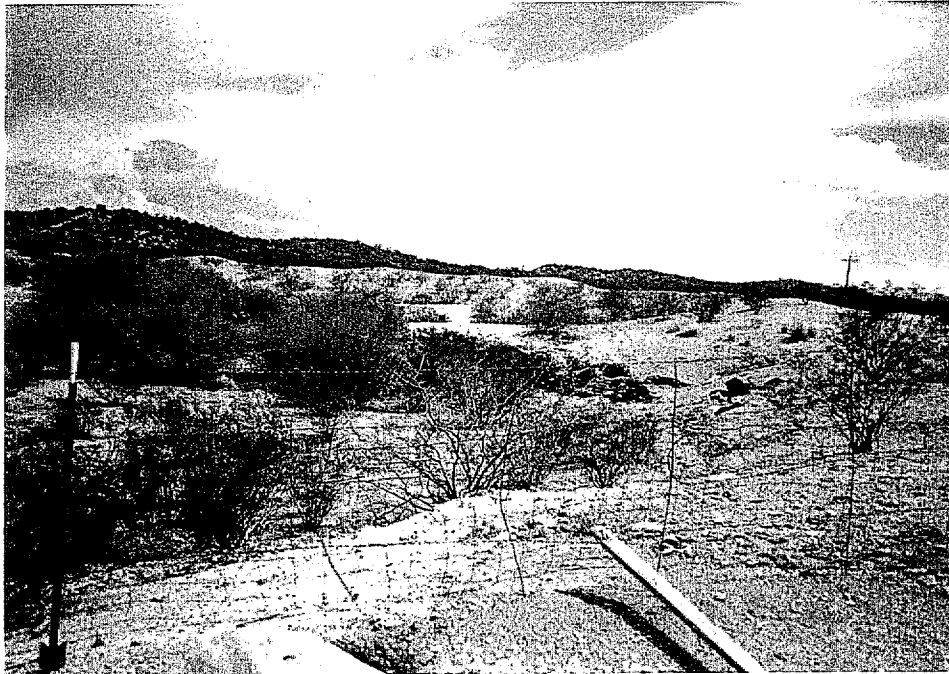
Photograph No. 6

View from the northeast corner of the pit looking southwest at the corral located near the south central portion of the Site.

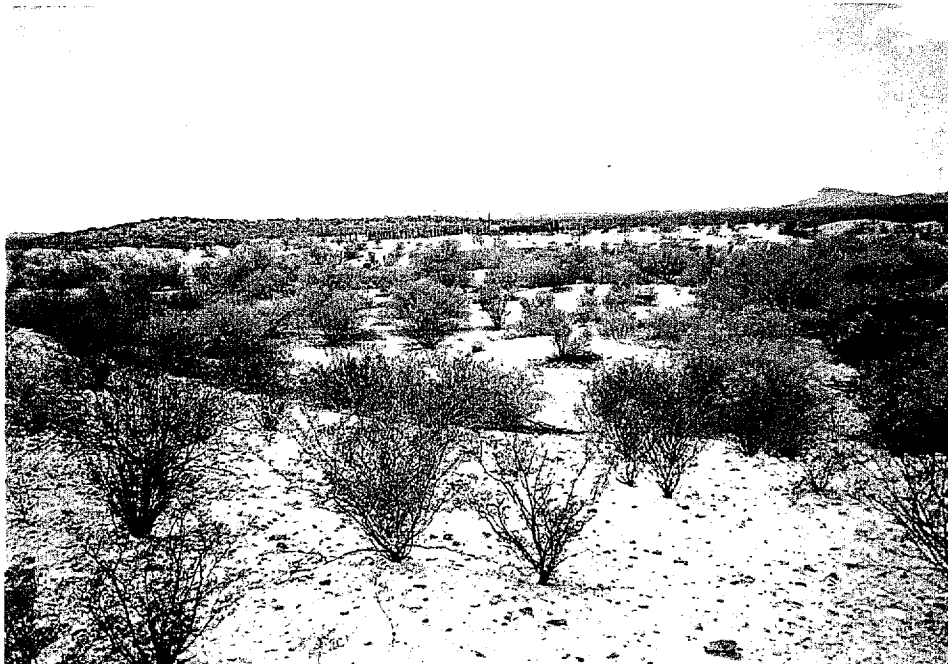
Photograph No. 7

View looking toward the east across the Site from the western edge of the pit.

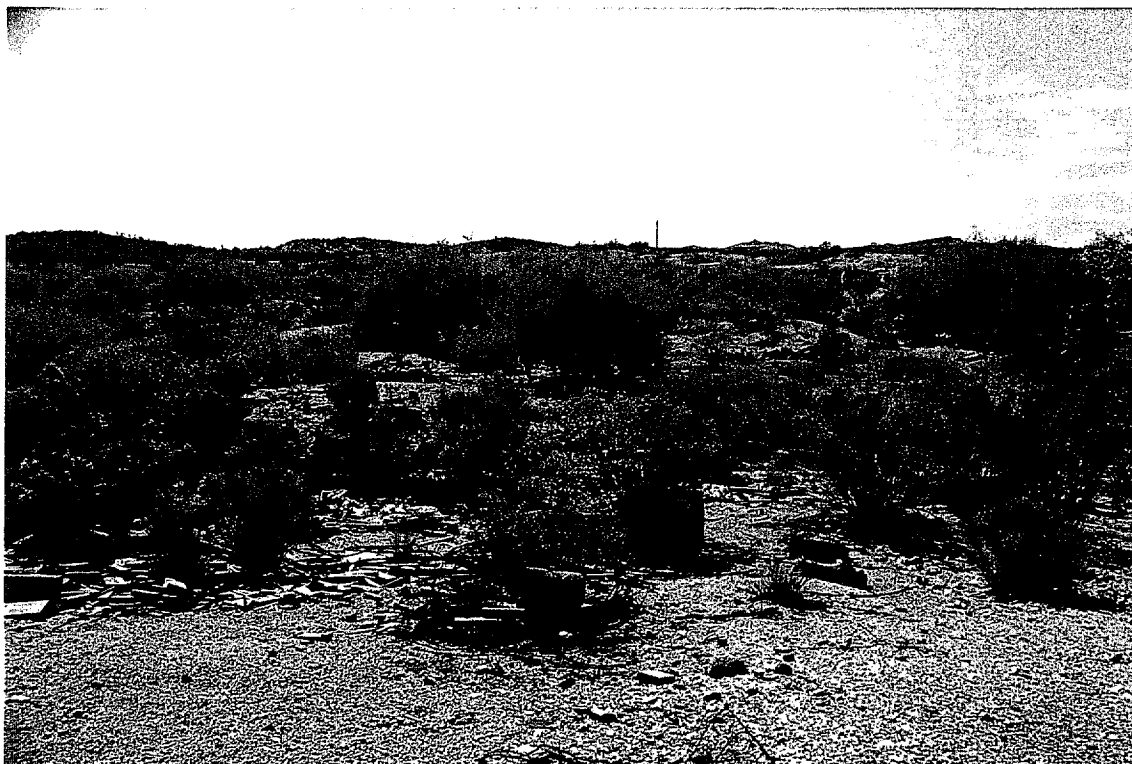
Photograph No. 11

View toward the south from the north edge of the pit showing the dump area on the Site.
